# Moving the Regulating Rod

Associate Director, Reed Reactor

TRTR 2005

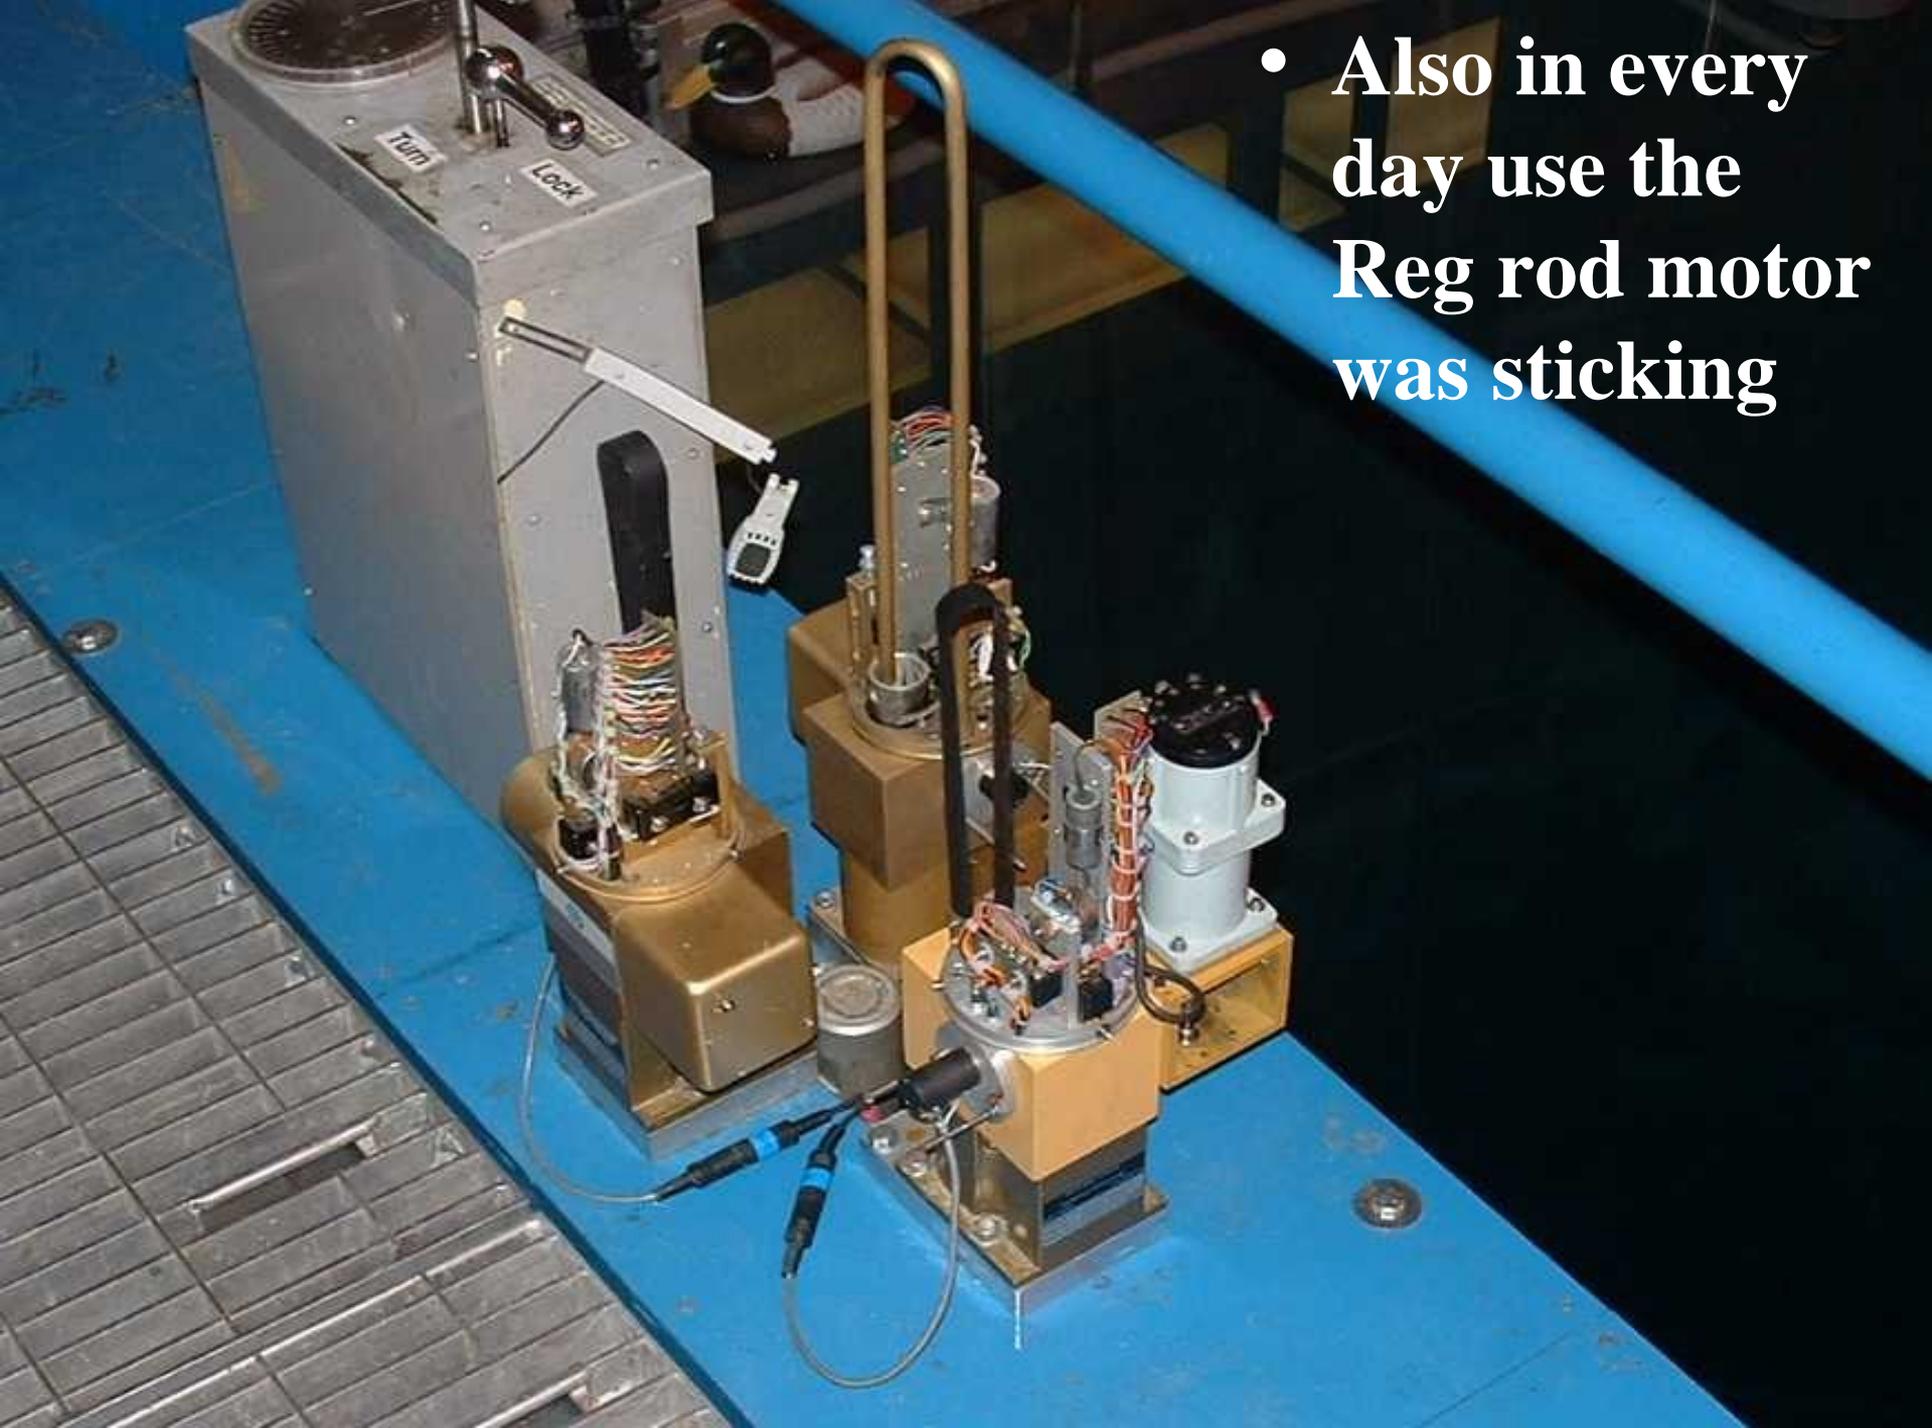
- For many years the Reg Rod showed some wear during inspections
- This wear accelerated after 2000

- Also in every day use the Reg rod motor was sticking

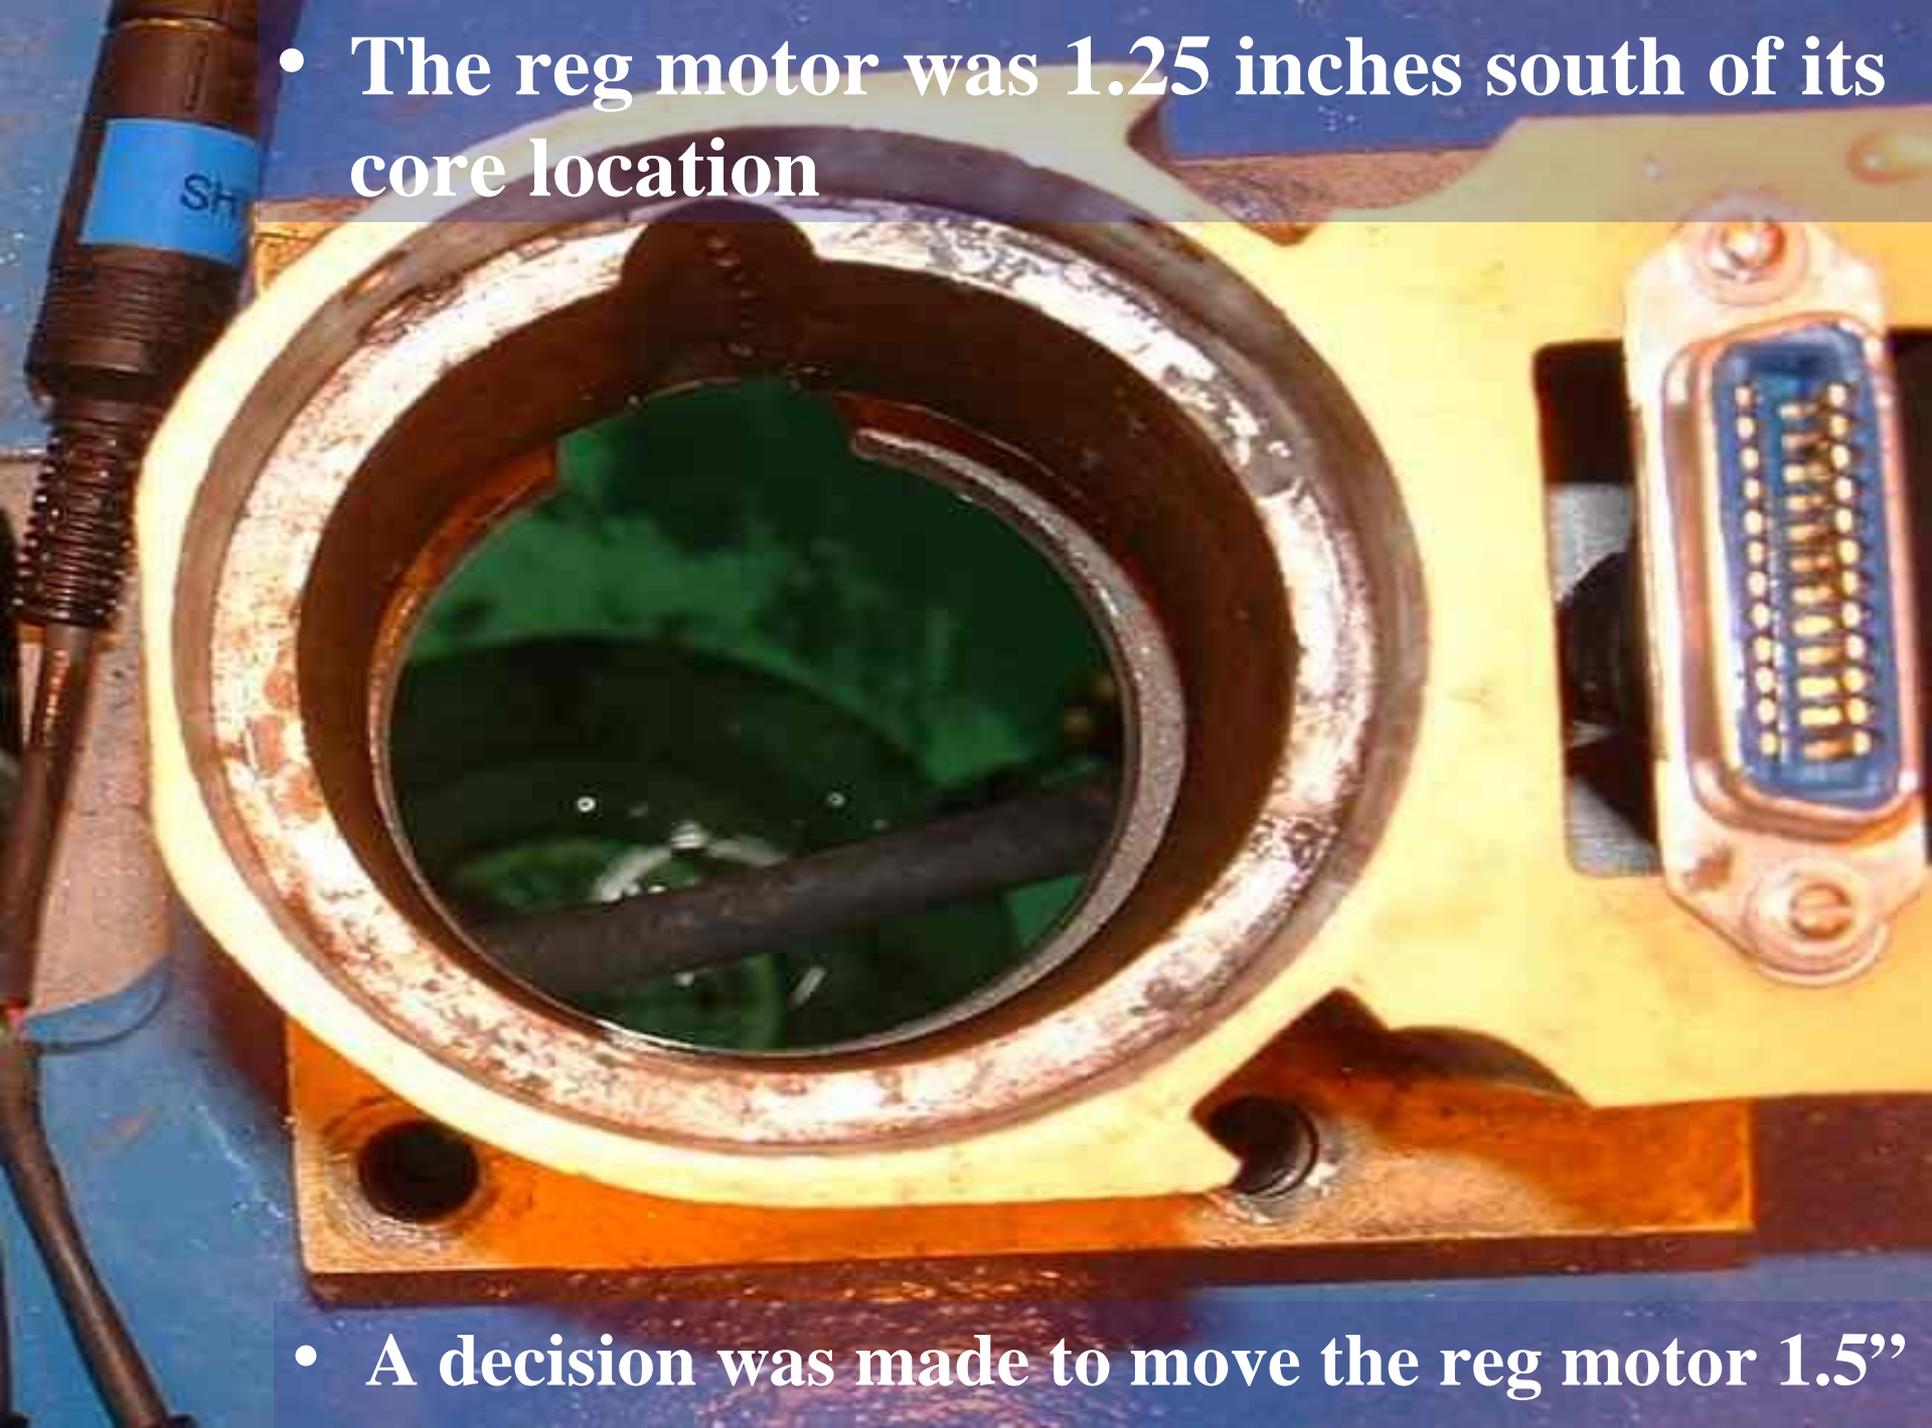
- The reg motor was 1.25 inches south of its core location

- A decision was made to move the reg motor 1.5''

- The deck plate had to be cut in place since all three rods go through it
