September 1, 2009

Compressed Gas Cylinder Restraint Failure

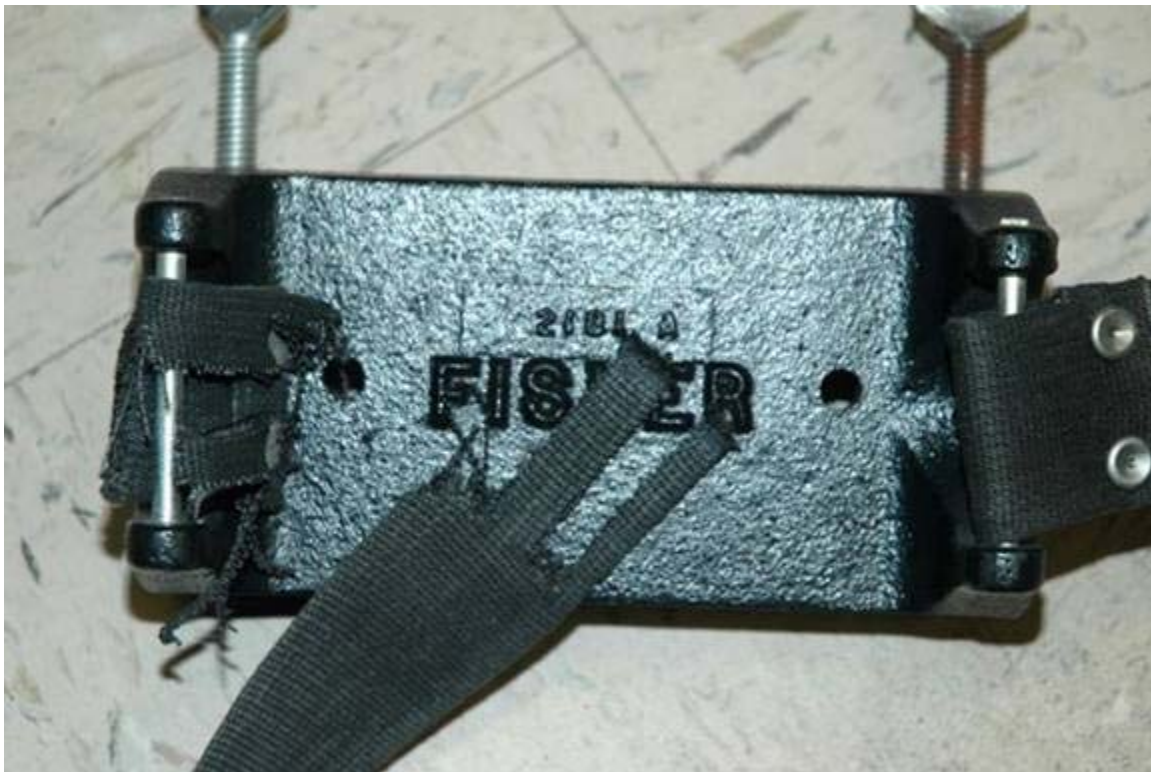
A colleague in the NIST Nanomechanical Properties Group was setting up a gas cylinder in his lab and wanted to confirm that the restraint was properly clamped to the bench so he yanked on the strap to test it. The clamp was fine but the strap (which looked fine visually) came apart (see picture below).

We may want to phase out fabric straps in favor of chains since in many labs the combination of age and environment in many chemical labs lead to enough loss in strength to be hazardous. Often this loss in strength is not apparent through visual inspection.

Please check the gas cylinder restraints in your area for integrity and consider replacing fabric strap with chains. Thank you.
