Time and Frequency Division had a near-miss that I'd like to report. One of our researchers was looking for potential heat sources in the lab. In the process of this, he was feeling various pieces of equipment to see how hot they were. He put his hand on a NIST NIM Bin (Nuclear Instrument Module Bin), which is basically a NIST-built power supply device that are prolific here in Boulder--and no, they are NOT "nuclear". He did not know that the caps that protected the -200V DC and +200V DC contacts were missing, and therefore managed to place his fingers on the -200V contact and his palm on the +200V contact. Luckily he was not injured nor burned. The researcher had inherited the NIM Bin, and we don't know why or how the caps were not present. They have since been replaced and the contacts are now protected.

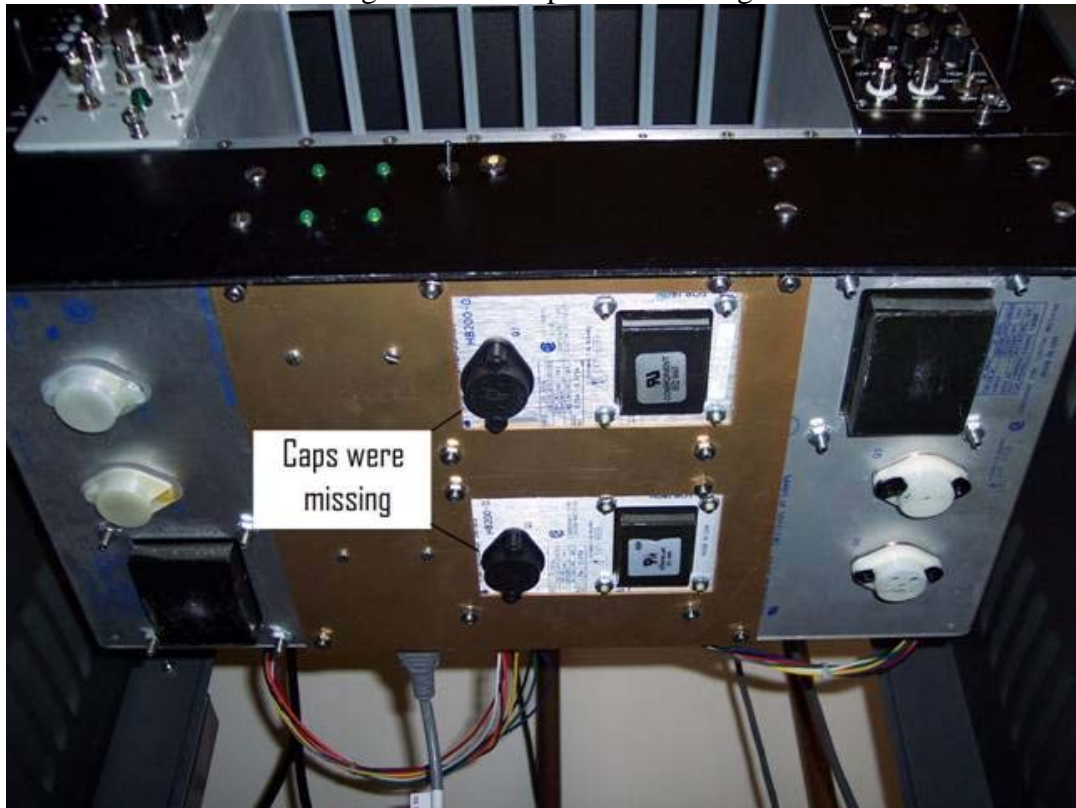
Bottom of NIM Bin showing where the caps were missing:

Please inspect any NIM Bin that you or your Division might possess (to be safe, please inspect both older and newer models)

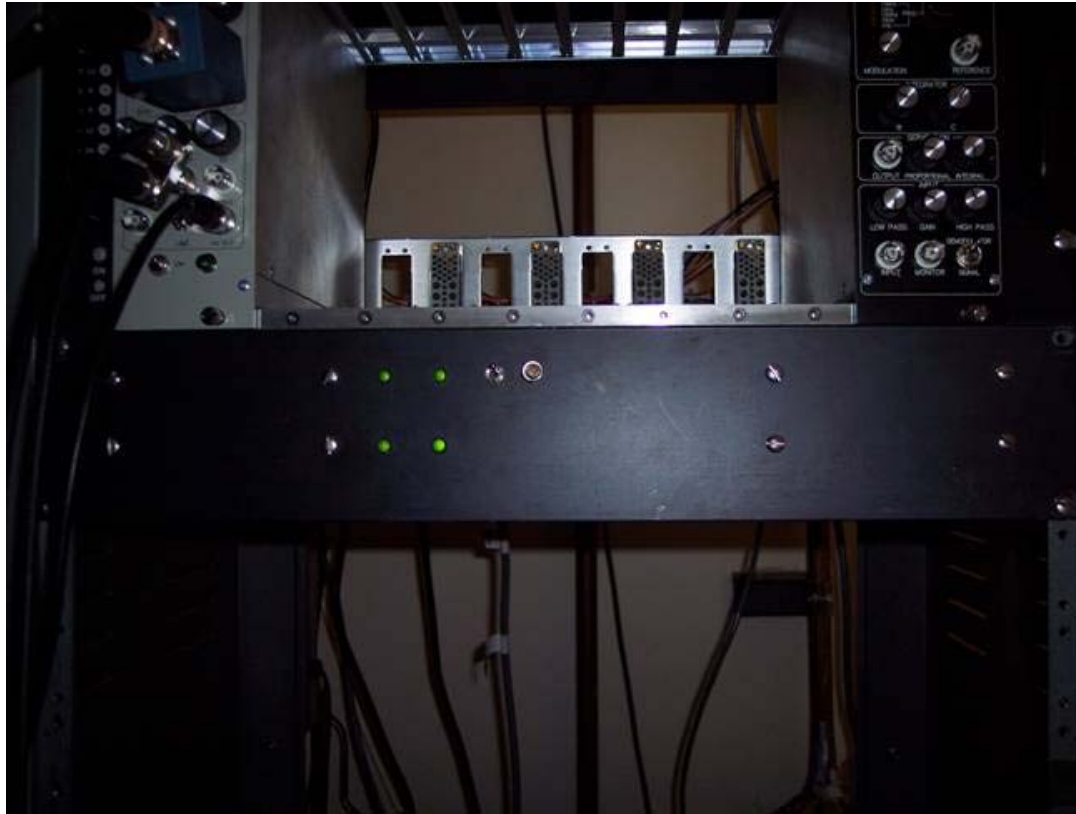
The model of NIM Bin that he has is an older model. The newer models have these caps glued into place so that they cannot be removed (at least in theory). I have included pictures below of the NIM Bin bottom with the questionable caps, the front panel of the older models, and the front panel of a newer model.

Front Panel of older model:

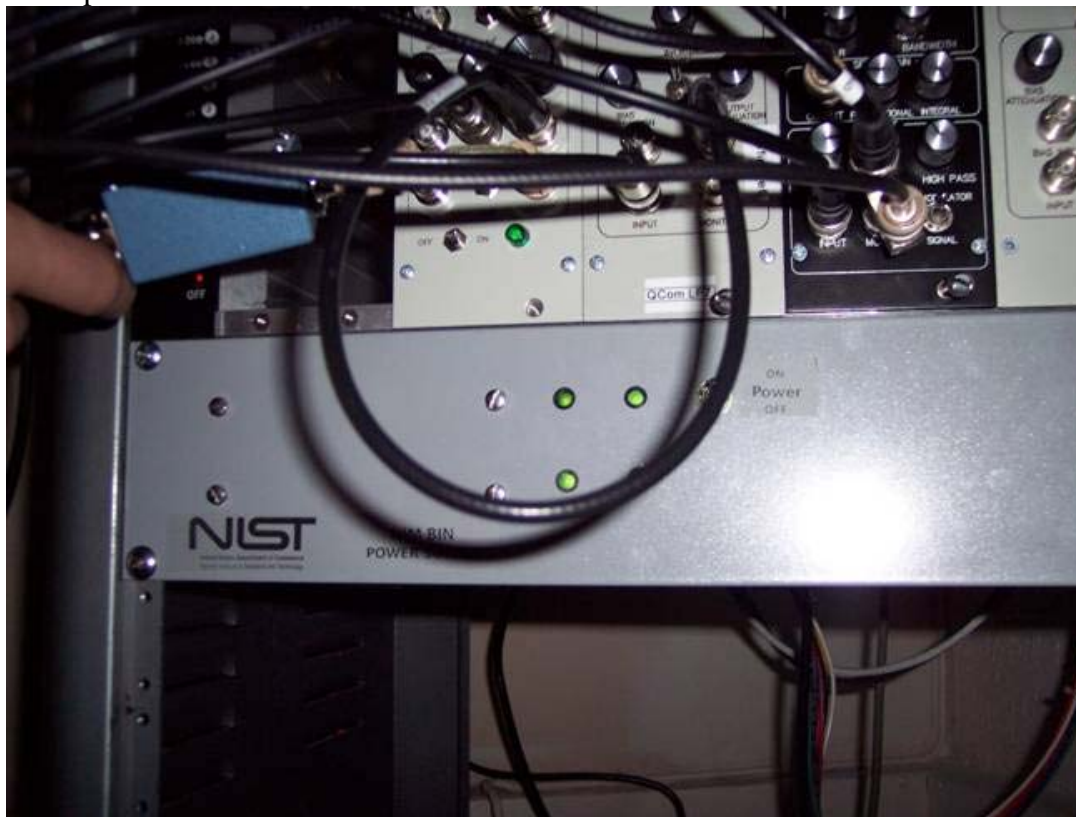
Front panel of newer model:
