Defective Squirt Bottle Incident

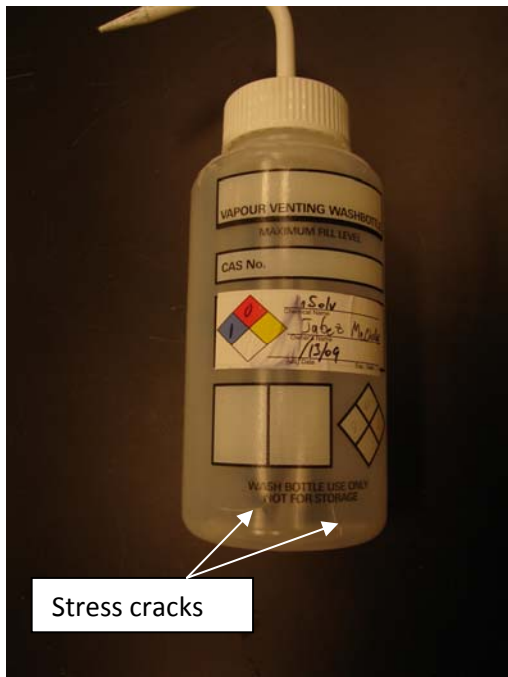
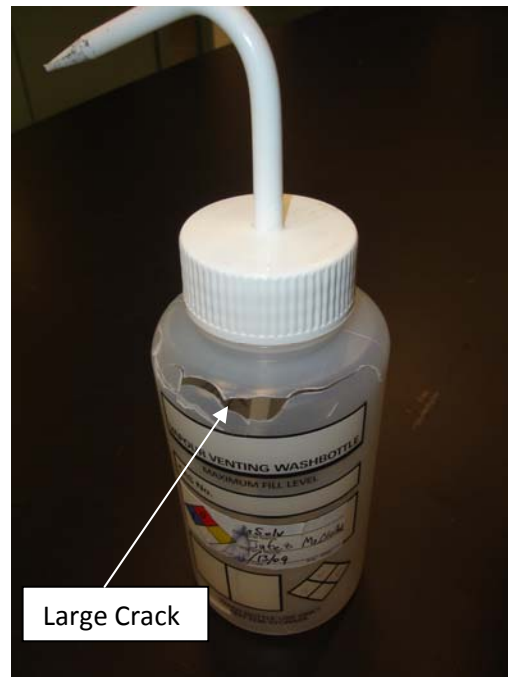
Last Friday November 13, 2009 the squirt bottle (pictured below) was partially filled with Ensolv and used in cleaning components during a metal seal valve rebuild. Prior to filling the bottle, it was visually inspected and no defects were noticed. Once the operation was completed, the bottle was placed on top of a piece of equipment on the lab bench. Approximately 2 hours later, the bottle was found as shown below and the contents had leaked out of the container onto the equipment.

Within CNST we have several squirt bottles with Ensolv contained in them and have never seen this type of failure. Some of them have contained Ensolv for a year or more. Following the present incident, all of these bottles were examined and tested and none were found to have any defects. Further investigation of the bottle involved in the incident suggests that it was most likely defective. Squeezing of the defective bottle probably cracked the material and this led to the solvent leaking out of the lower stress cracks.

1. Prior to filling squirt bottles with solvents or any chemical, you should not only visually inspect these bottles but also squeeze test them to verify they are in good working condition.
2. When solvent squirt bottles are not in use, they should be stored in a secondary containment bin so if they do leak, the spill is contained.

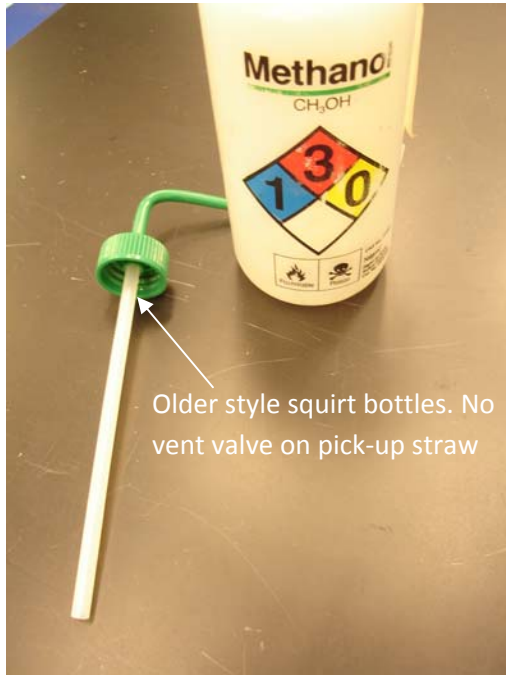
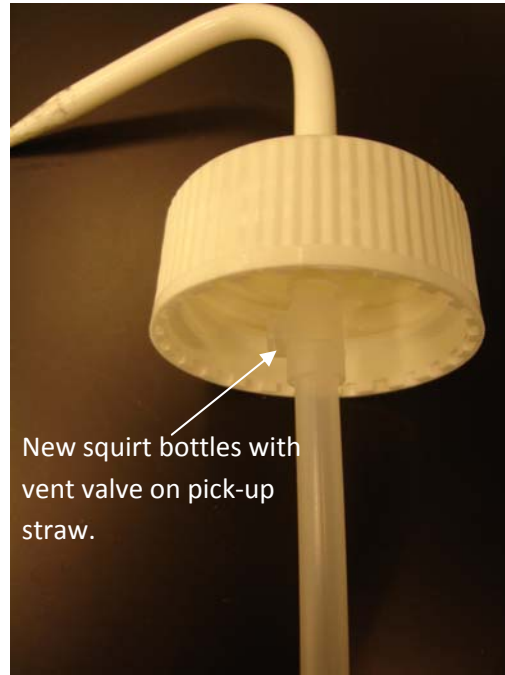
OLD STYLE SQUIRT BOTTLE NOTICE

Another safety issue that came up during this investigation was that several labs are still using the old style, non-venting squirt bottles. These bottles can build up internal pressure and can squirt out the

contents at any time. The use of the non-venting squirt bottles should be discontinued at once and replaced with the vented type. The vented types of squirt bottles are available in the NIST storeroom.
