USGS Upgrading and Refurbishing of Secondary Cooling System and Air Monitor

September 16, 2005

Tim DeBey
USGS Reactor Supervisor

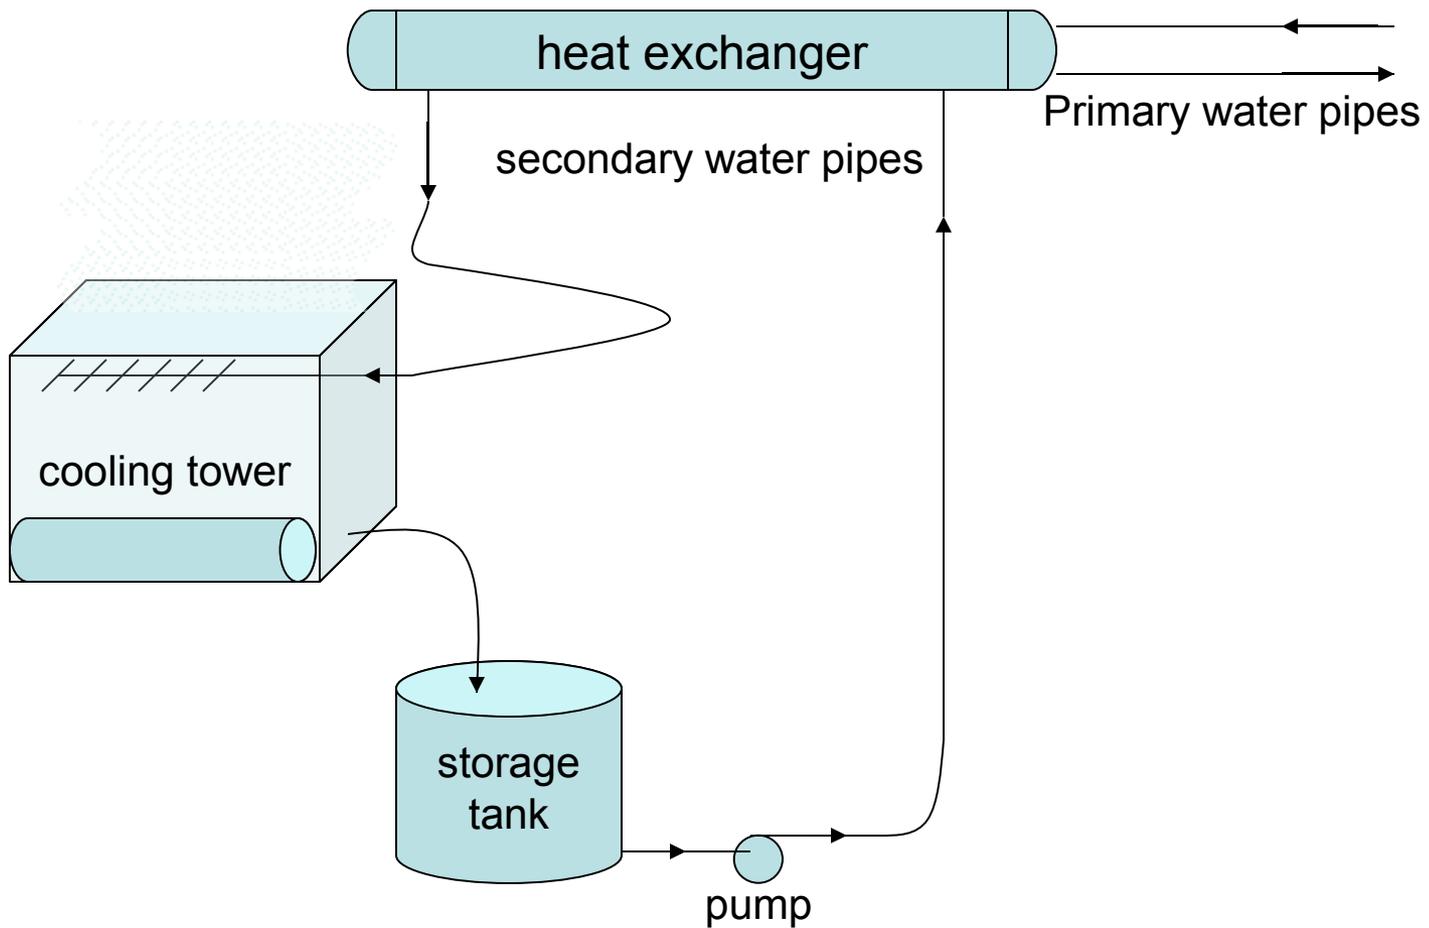
Secondary Cooling System Line Diagram

Secondary Cooling System Original Specifications:

- nominal water flow at 700 gpm
- single stage vertical turbine pump w/30 hp electric motor
- counterflow evaporative cooling tower
- four squirrel cage fans powered by 20 hp electric motor
- fan bearings were oil-lubricated, bronze bushings
- tower fill was asbestos-based
- tower structure was of hot-dipped galvanized steel
- spray nozzles are polypropylene, cleanable, mounted on 6" centers
- rated to cool 1 MW TRIGA facility

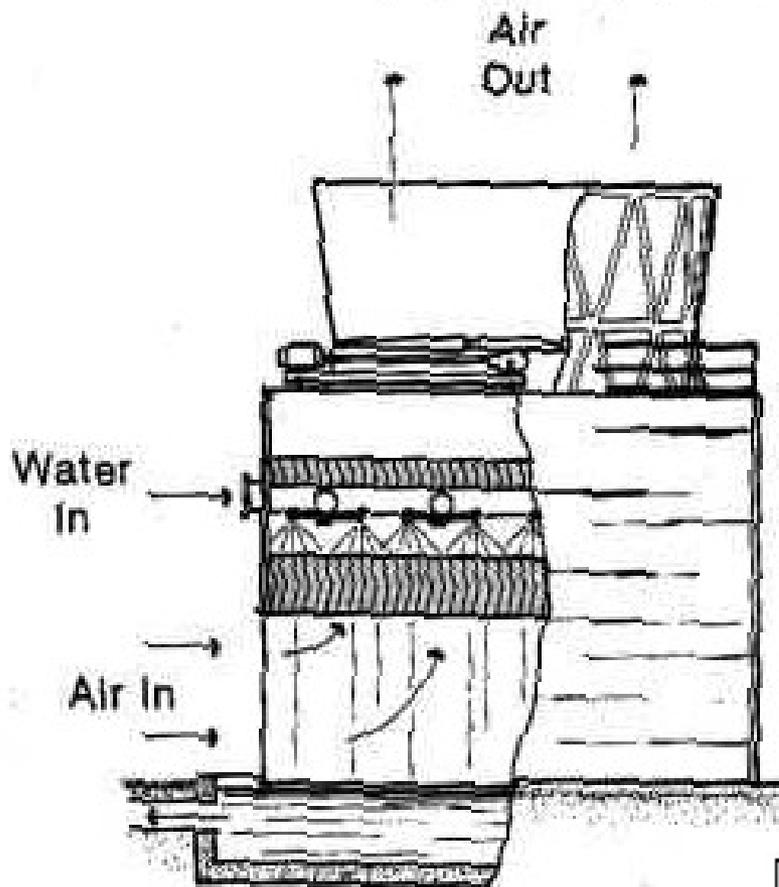
Counterflow cooling tower

- first job was to get rid of asbestos-containing fill
- asbestos removal took 2 days and cost \$4000
- tower interior was then sandblasted, a hole patched, and regalvanized
- interior was then coated with a urethane coating
- shaft and bearings for four squirrel cage fans were replaced
- new PVC fill was installed
- interior was cleaned, and access holes sealed
- pump was started and spray nozzles cleaned
- site cleanup found dust pan and foxtail brush missing (in tower)
- tower was reopened, pan and brush removed, and resealed
- post-job tests showed air flow from fans decreased by ~30%
- fan inspection showed squirrel cage units installed backwards
- fans were removed, turned around and reinstalled
- one drift eliminator was damaged by contractor and replaced

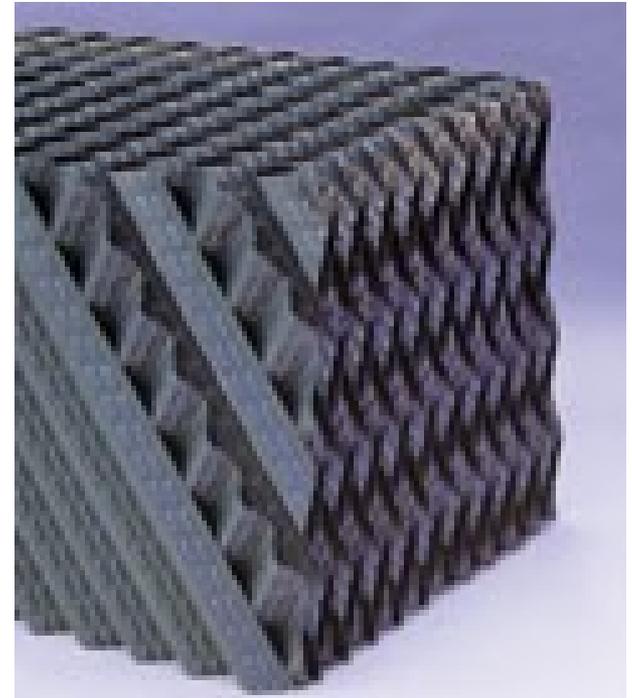
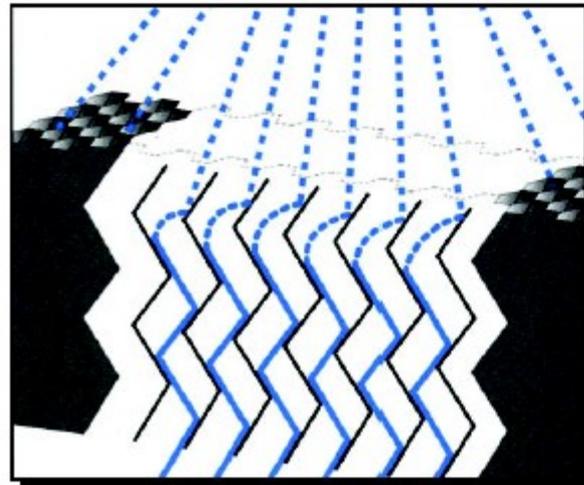
Film-Type Fill

Film-type fill distributes thin, even layers of water for maximum air exposure and cooling efficiency. PVC construction resists decay, corrosion and microorganisms, plus handles temperatures to 130°F.

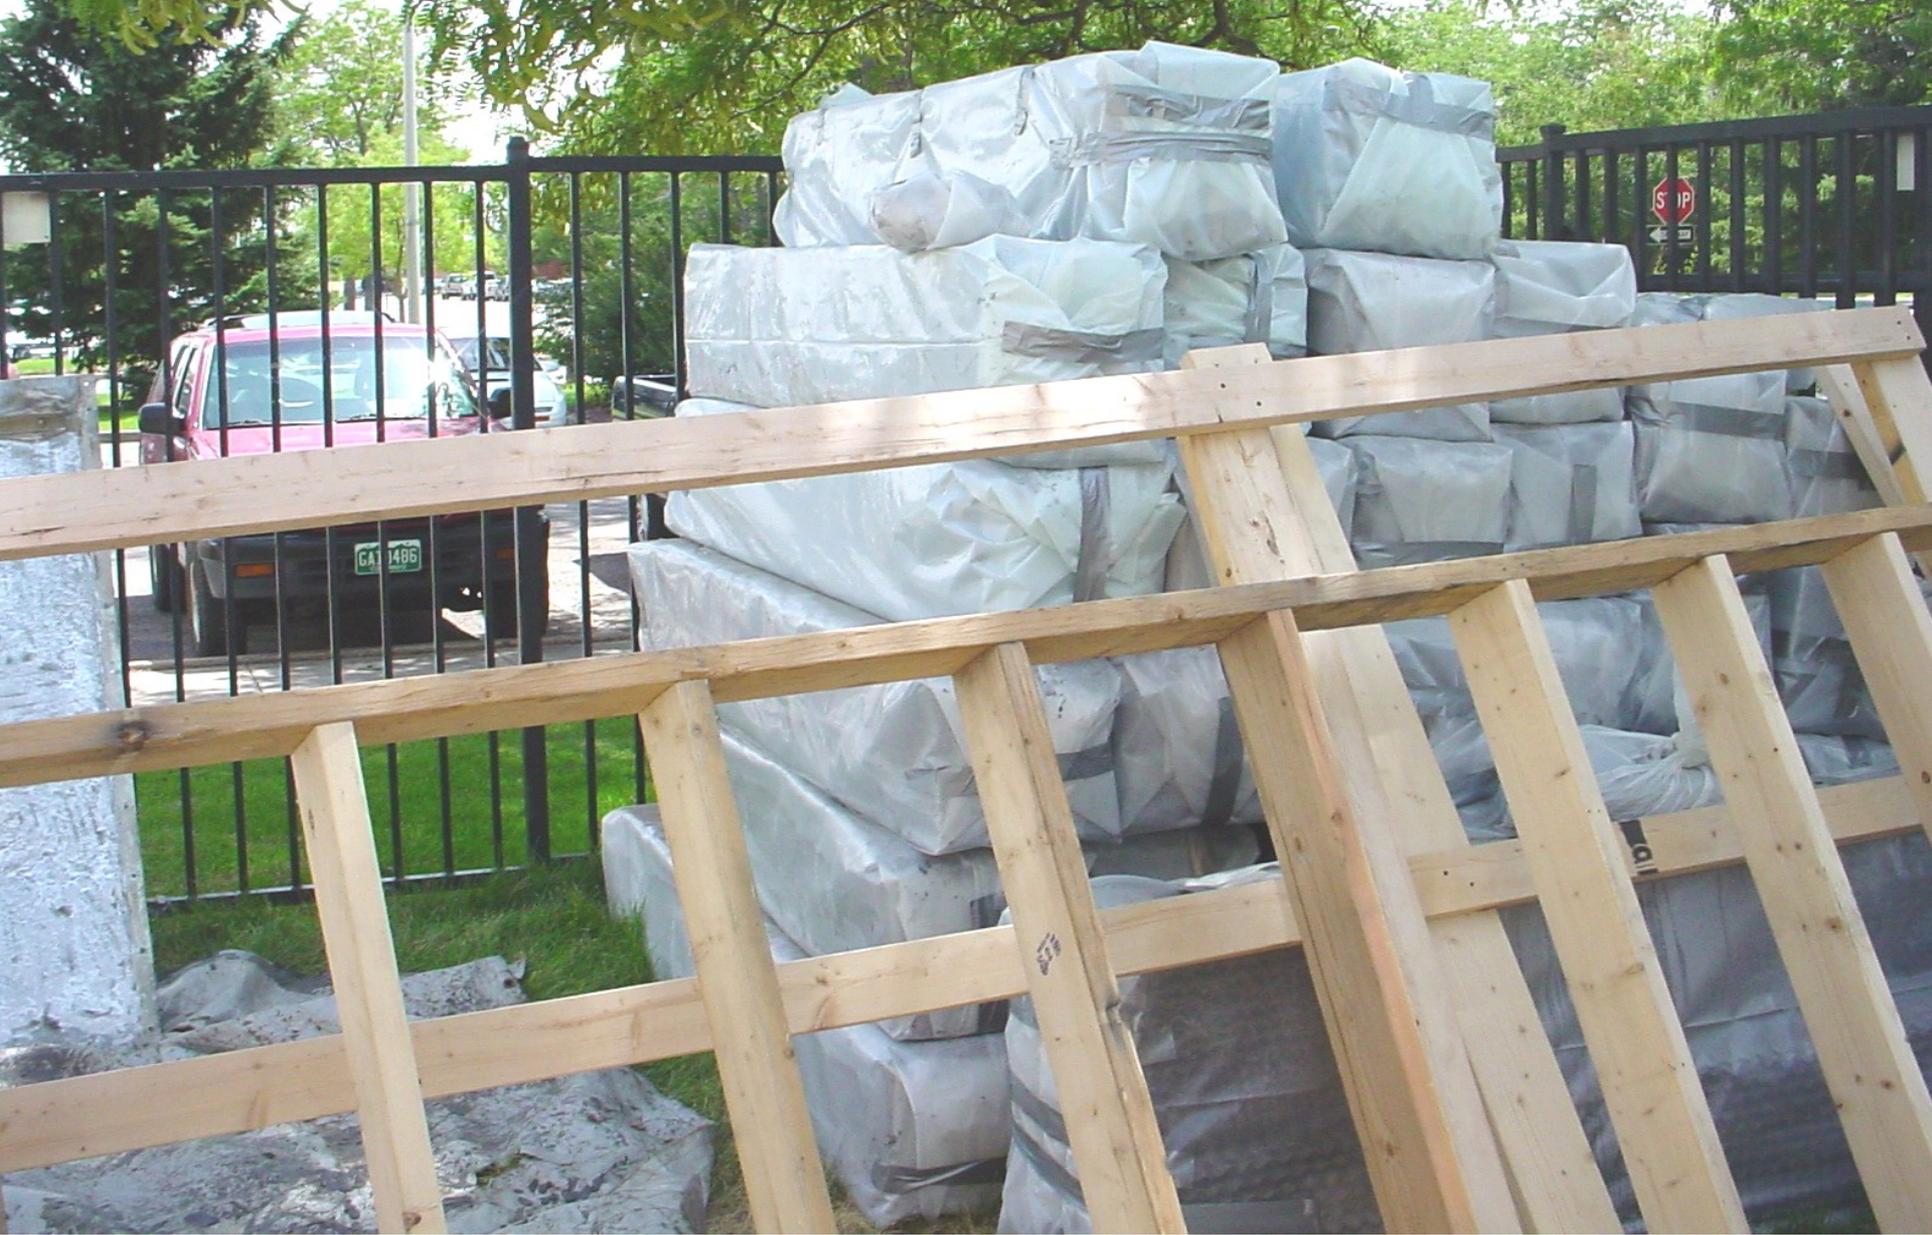
Old Fill From Cooling Tower

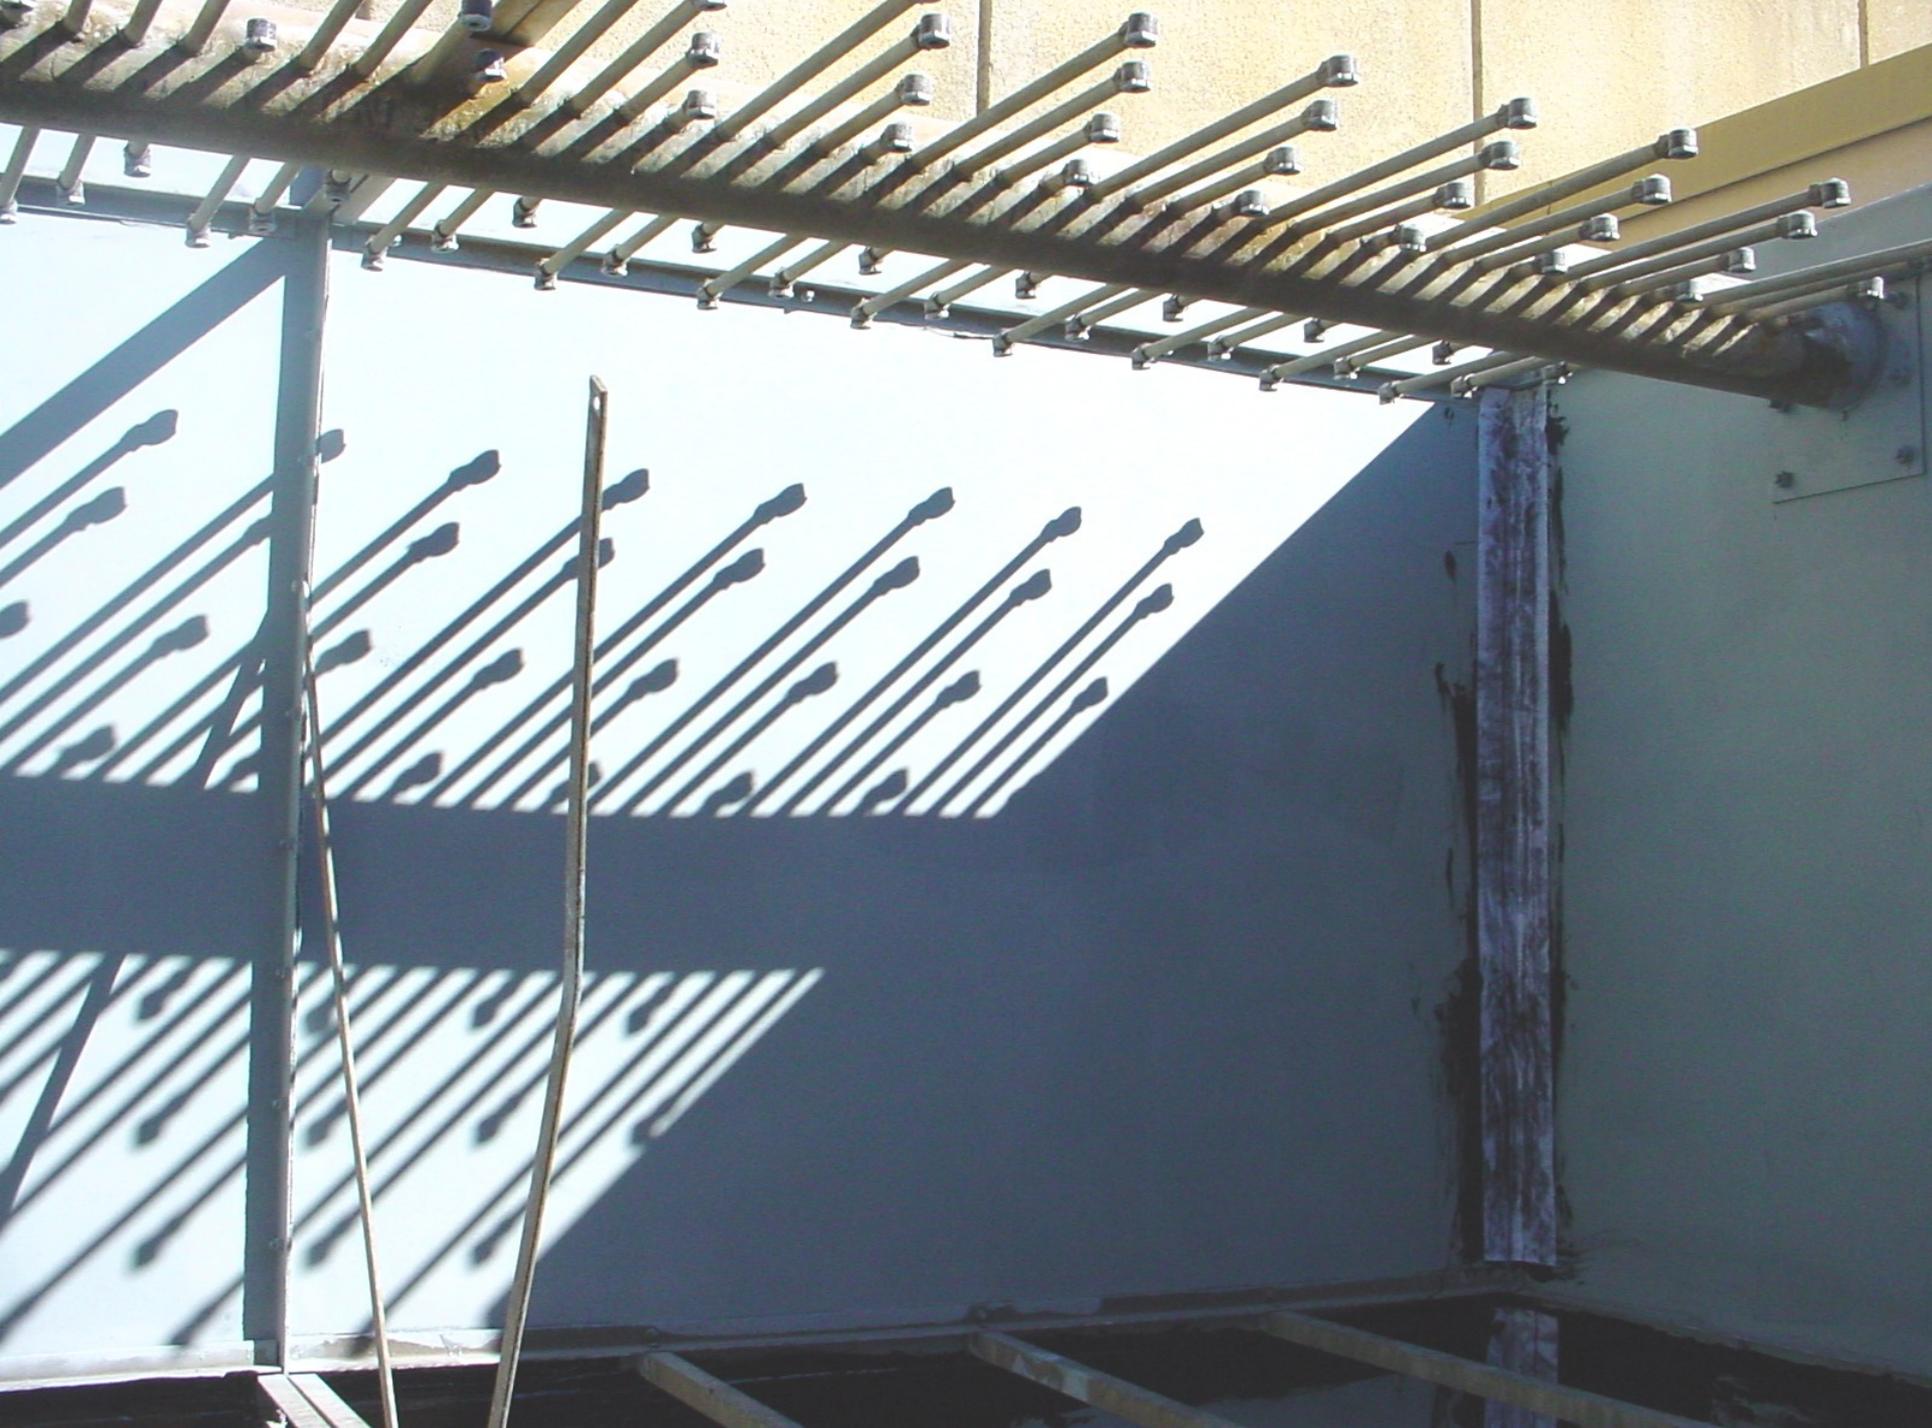
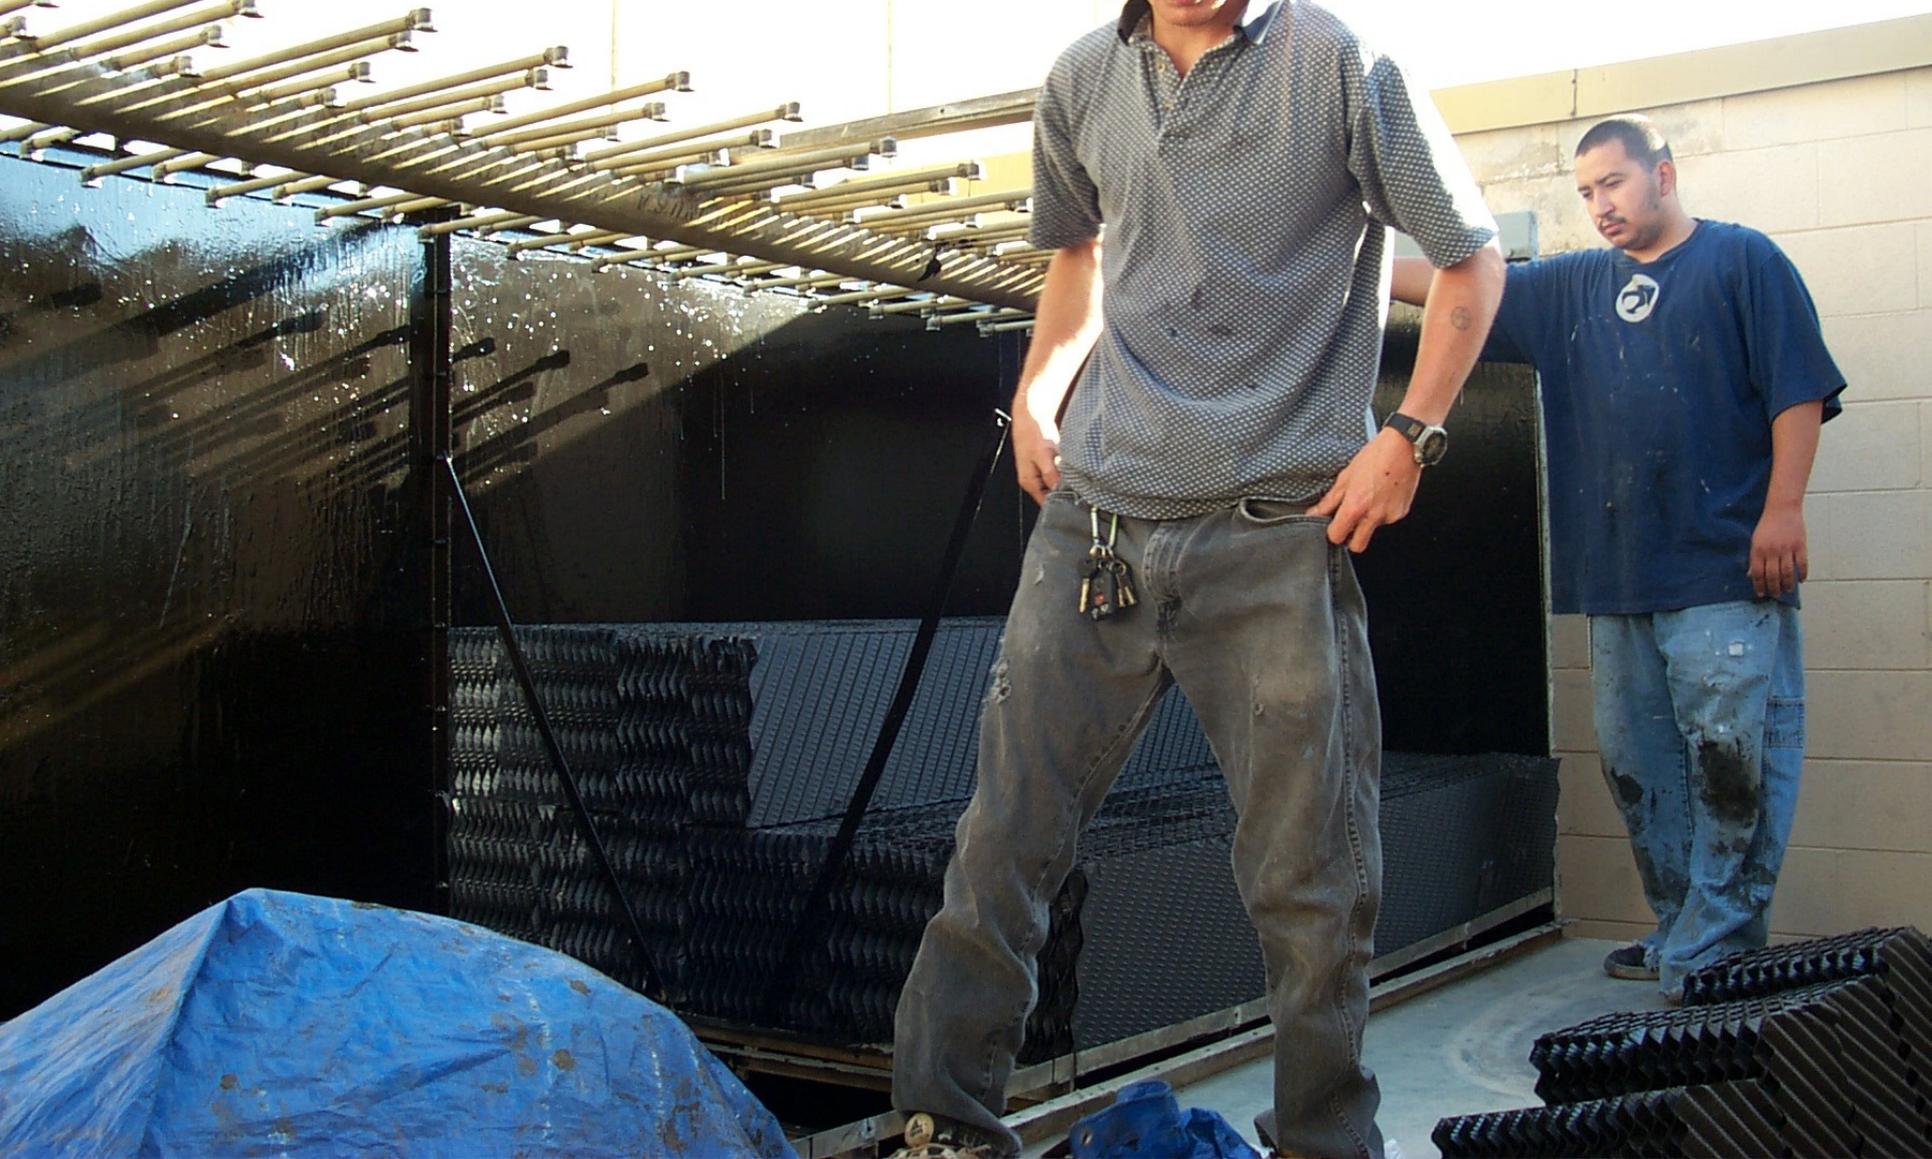
New Fill Being Installed In Cooling Tower

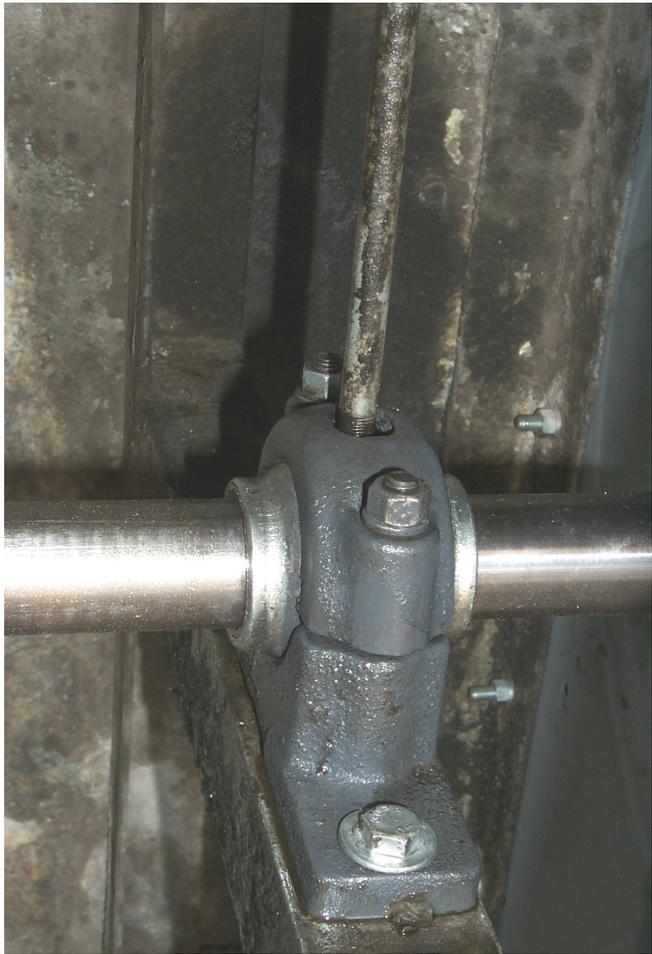
Fan shaft and bearing

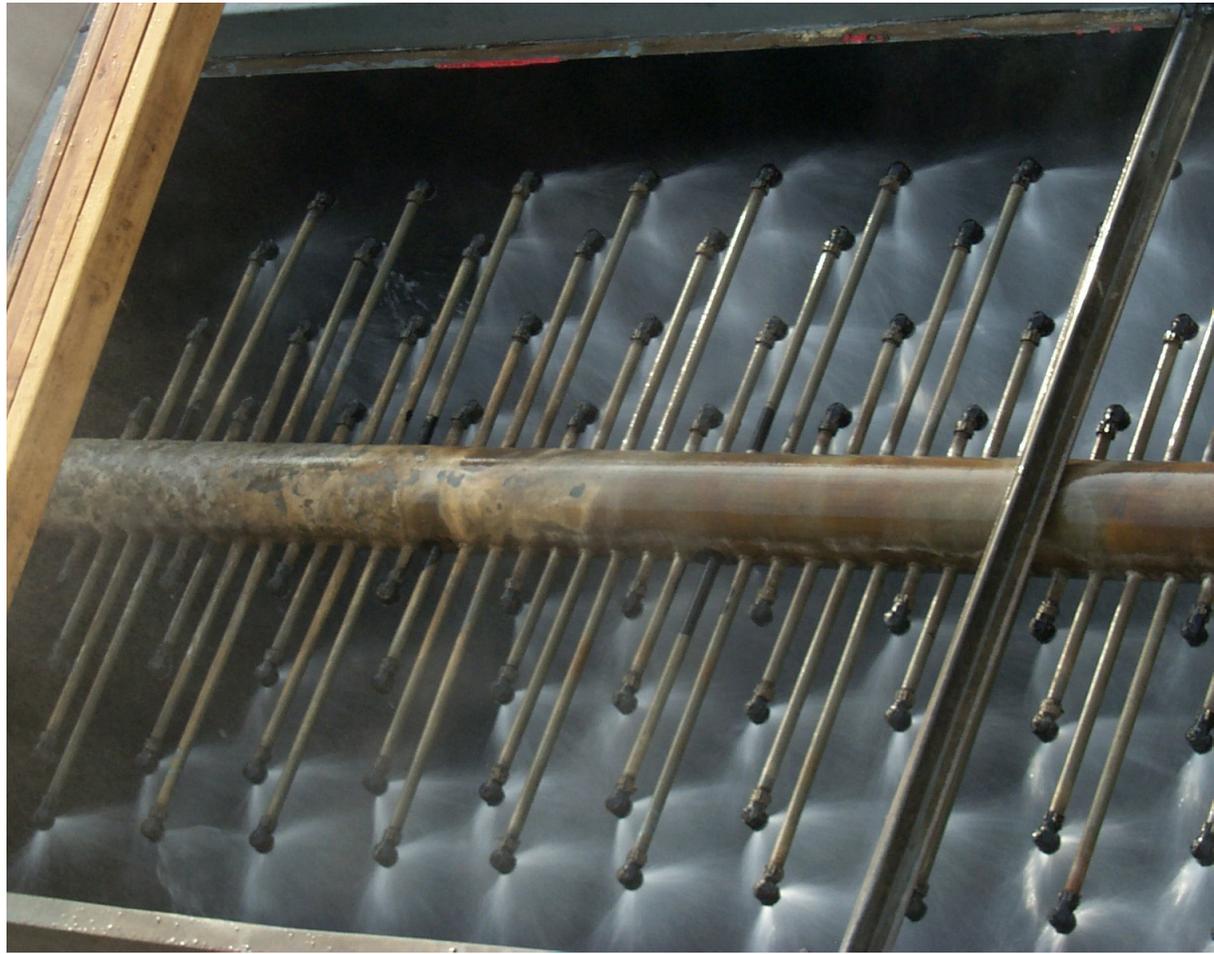
Spray nozzles on cooling tower
(note nozzles on left are plugged)

- clean, sandblast, paint, and coat inside of 3000 gal tank
- replace secondary pump and motor
- refurbish cooling tower:
 - clean spray nozzles
 - sandblast interior, regalvanize, apply coating
 - replace asbestos fill with PVC fill
 - replace fan bearings and shaft

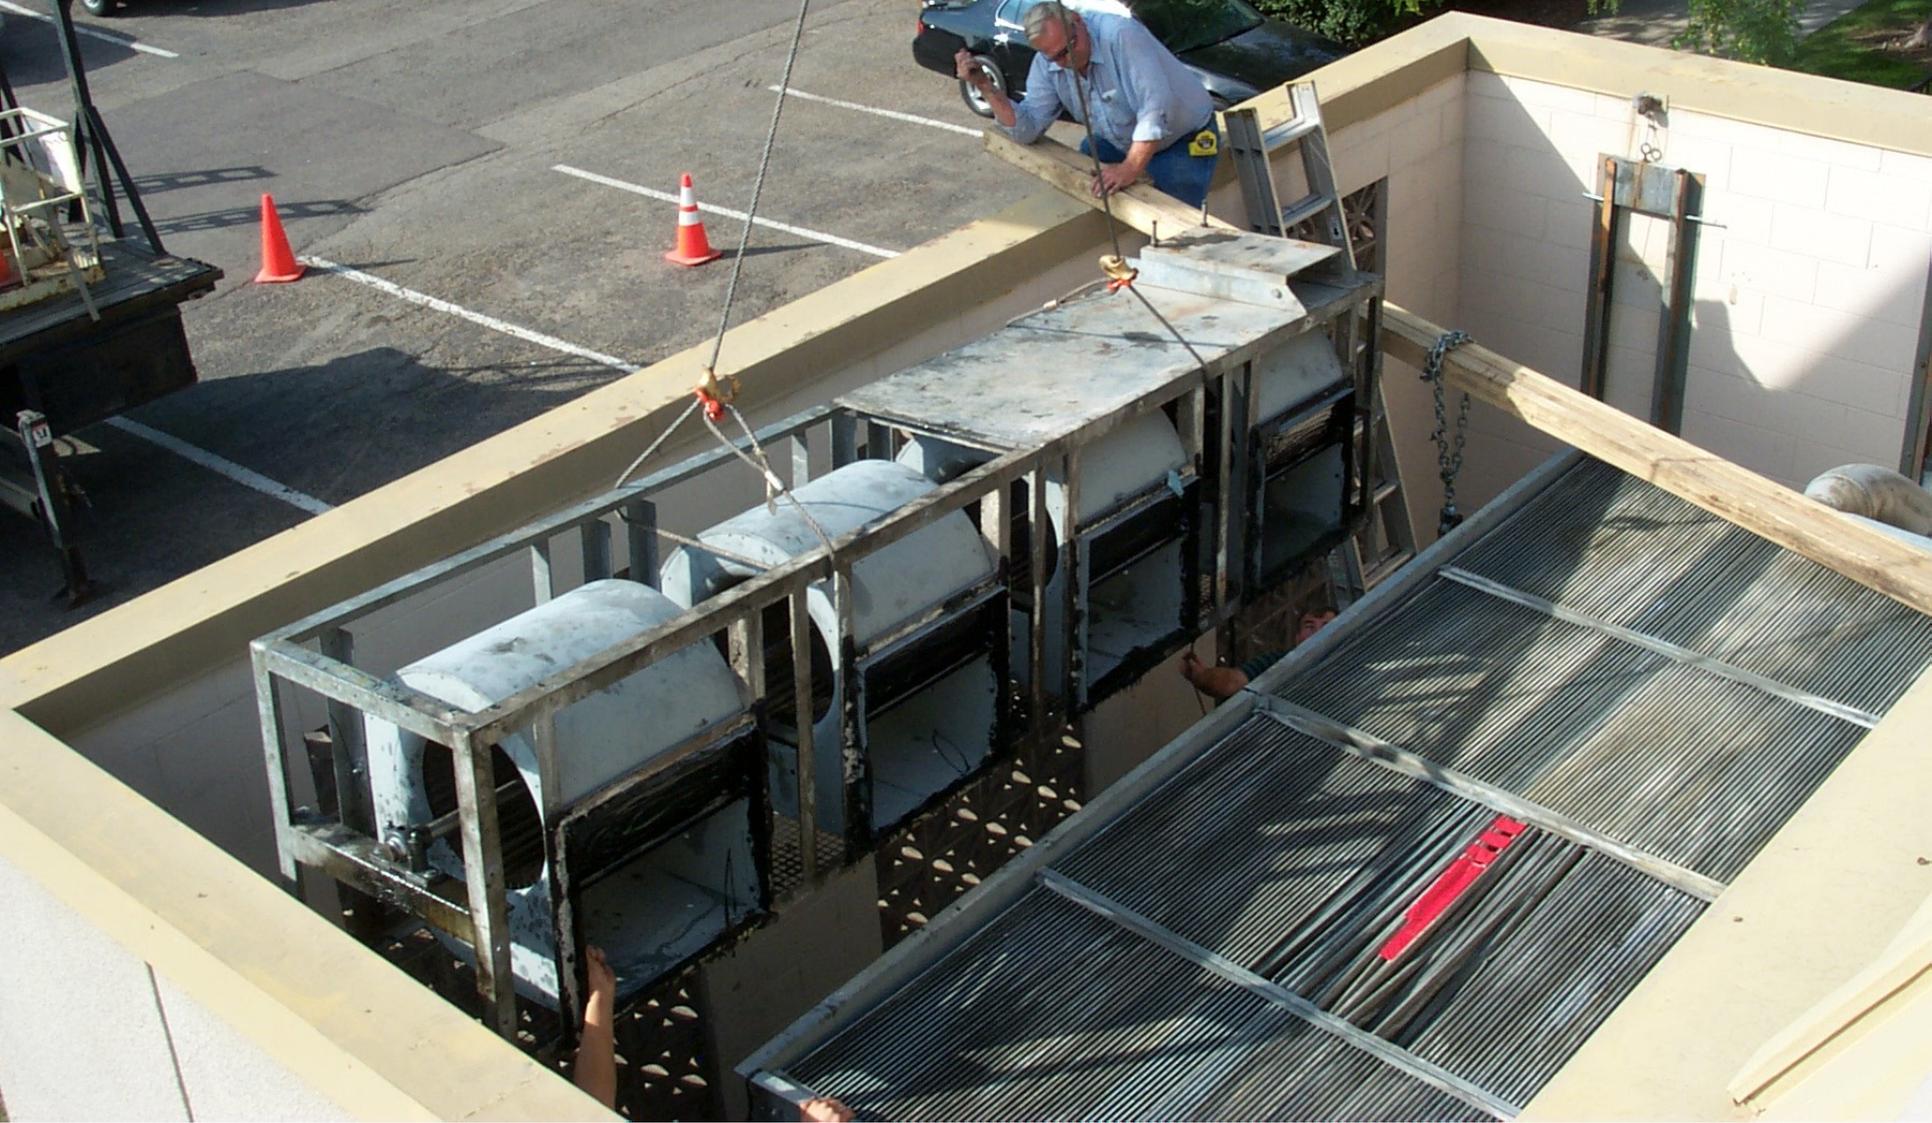
Moving Squirrel Cage Fans From Cooling Tower

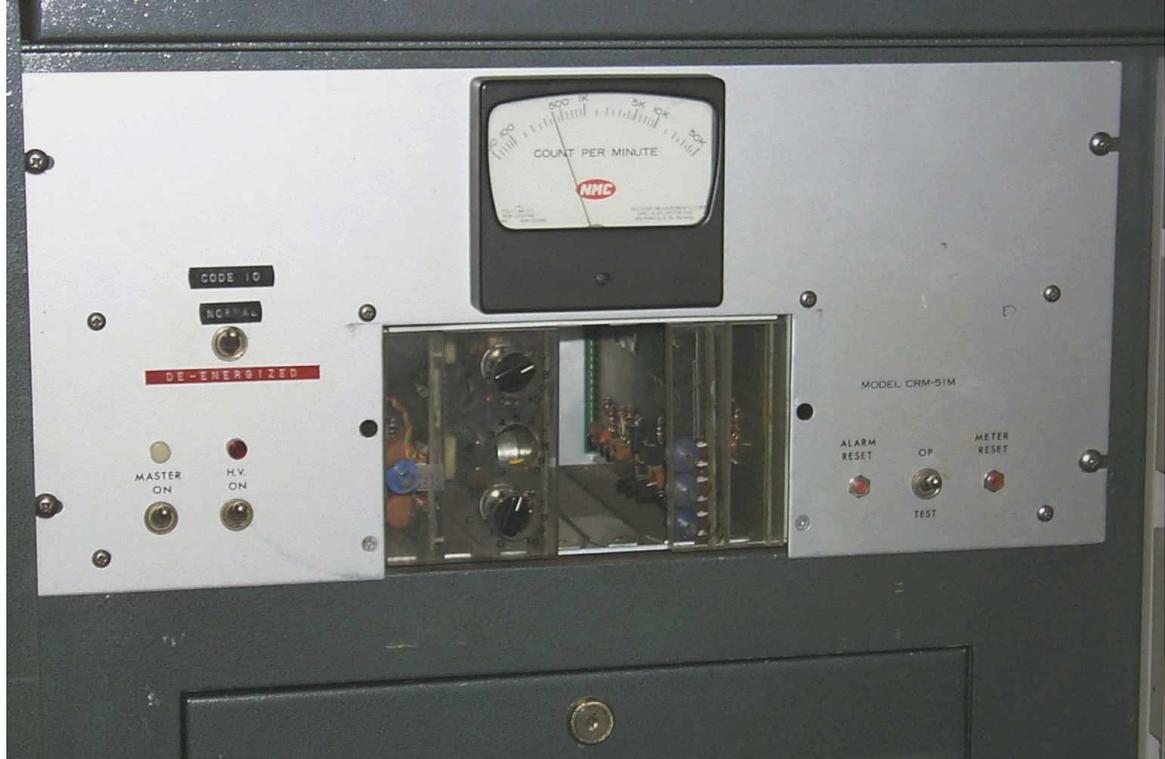
- original CAM was an NMC model AM-2A with a thin, end-window GM detector
- original electronics included low and high setpoint alarms and ratemeter
- original electronics were 1967 vintage discrete components
- CAM was exhibiting significant daily calibration drift
- replacement parts were hard or impossible to find

Original CAM electronics

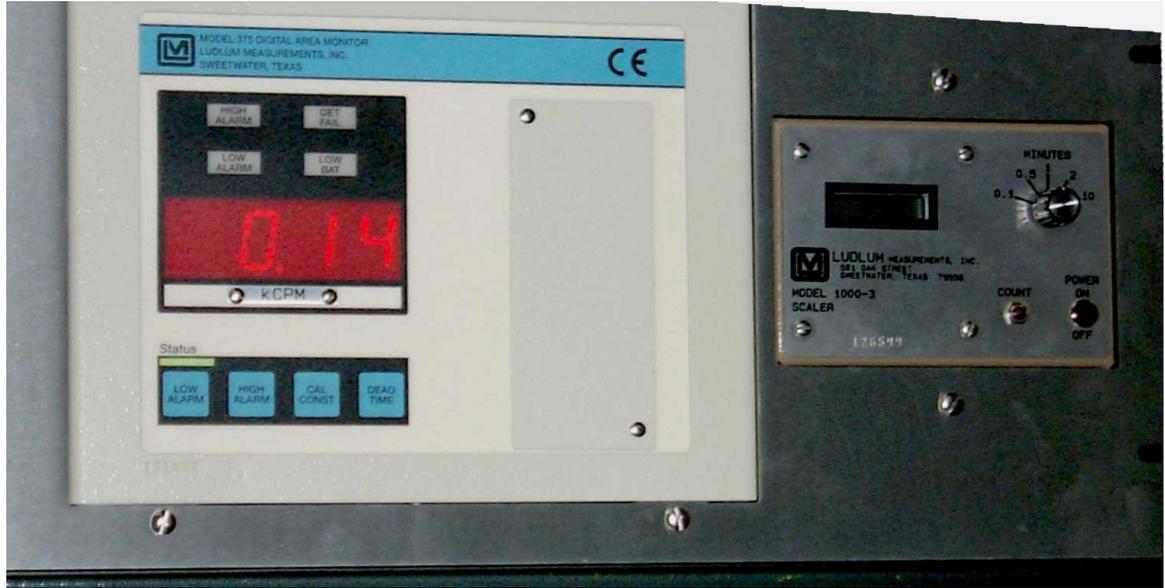
Ludlum Measurements, Inc, provided custom-modified Model 375 monitor mounted on a face plate to meet USGS specifications for the replacement electronics.

Replacement CAM electronics

- Replacement of CAM electronics was done for a total cost of \$1875 and one day of shutdown time.
- Replacement was performed by reactor staff.
- The CAM has worked well in the ~5 years since the upgrade.
- The system is very stable, easy to operate and easy to calibrate
