# Moving the Regulating Rod

Associate Director, Reed Reactor

TRTR 2005

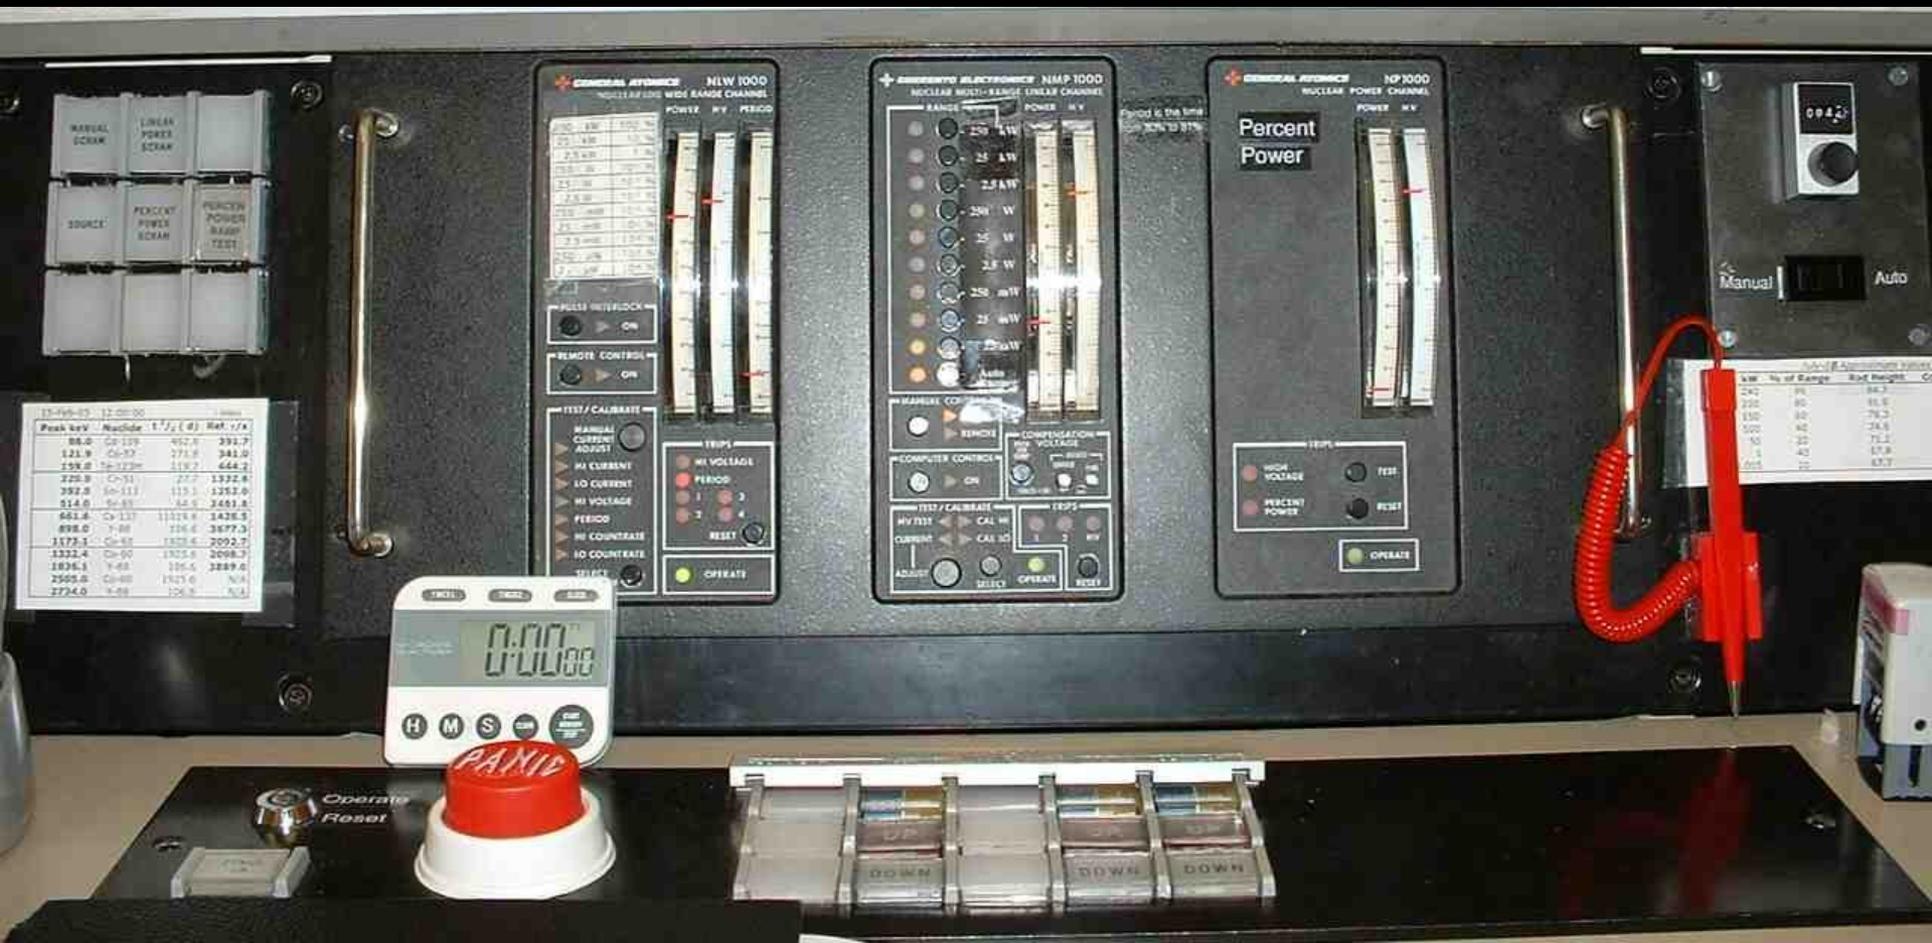
- A possibility is that the cause of the accelerated wear on the rod and motor was due the change to put all rods down rather than scrambling in 2000, since...

- The reg motor was 1.25 inches south of its core location

- A decision was made to move the reg motor 1.5''

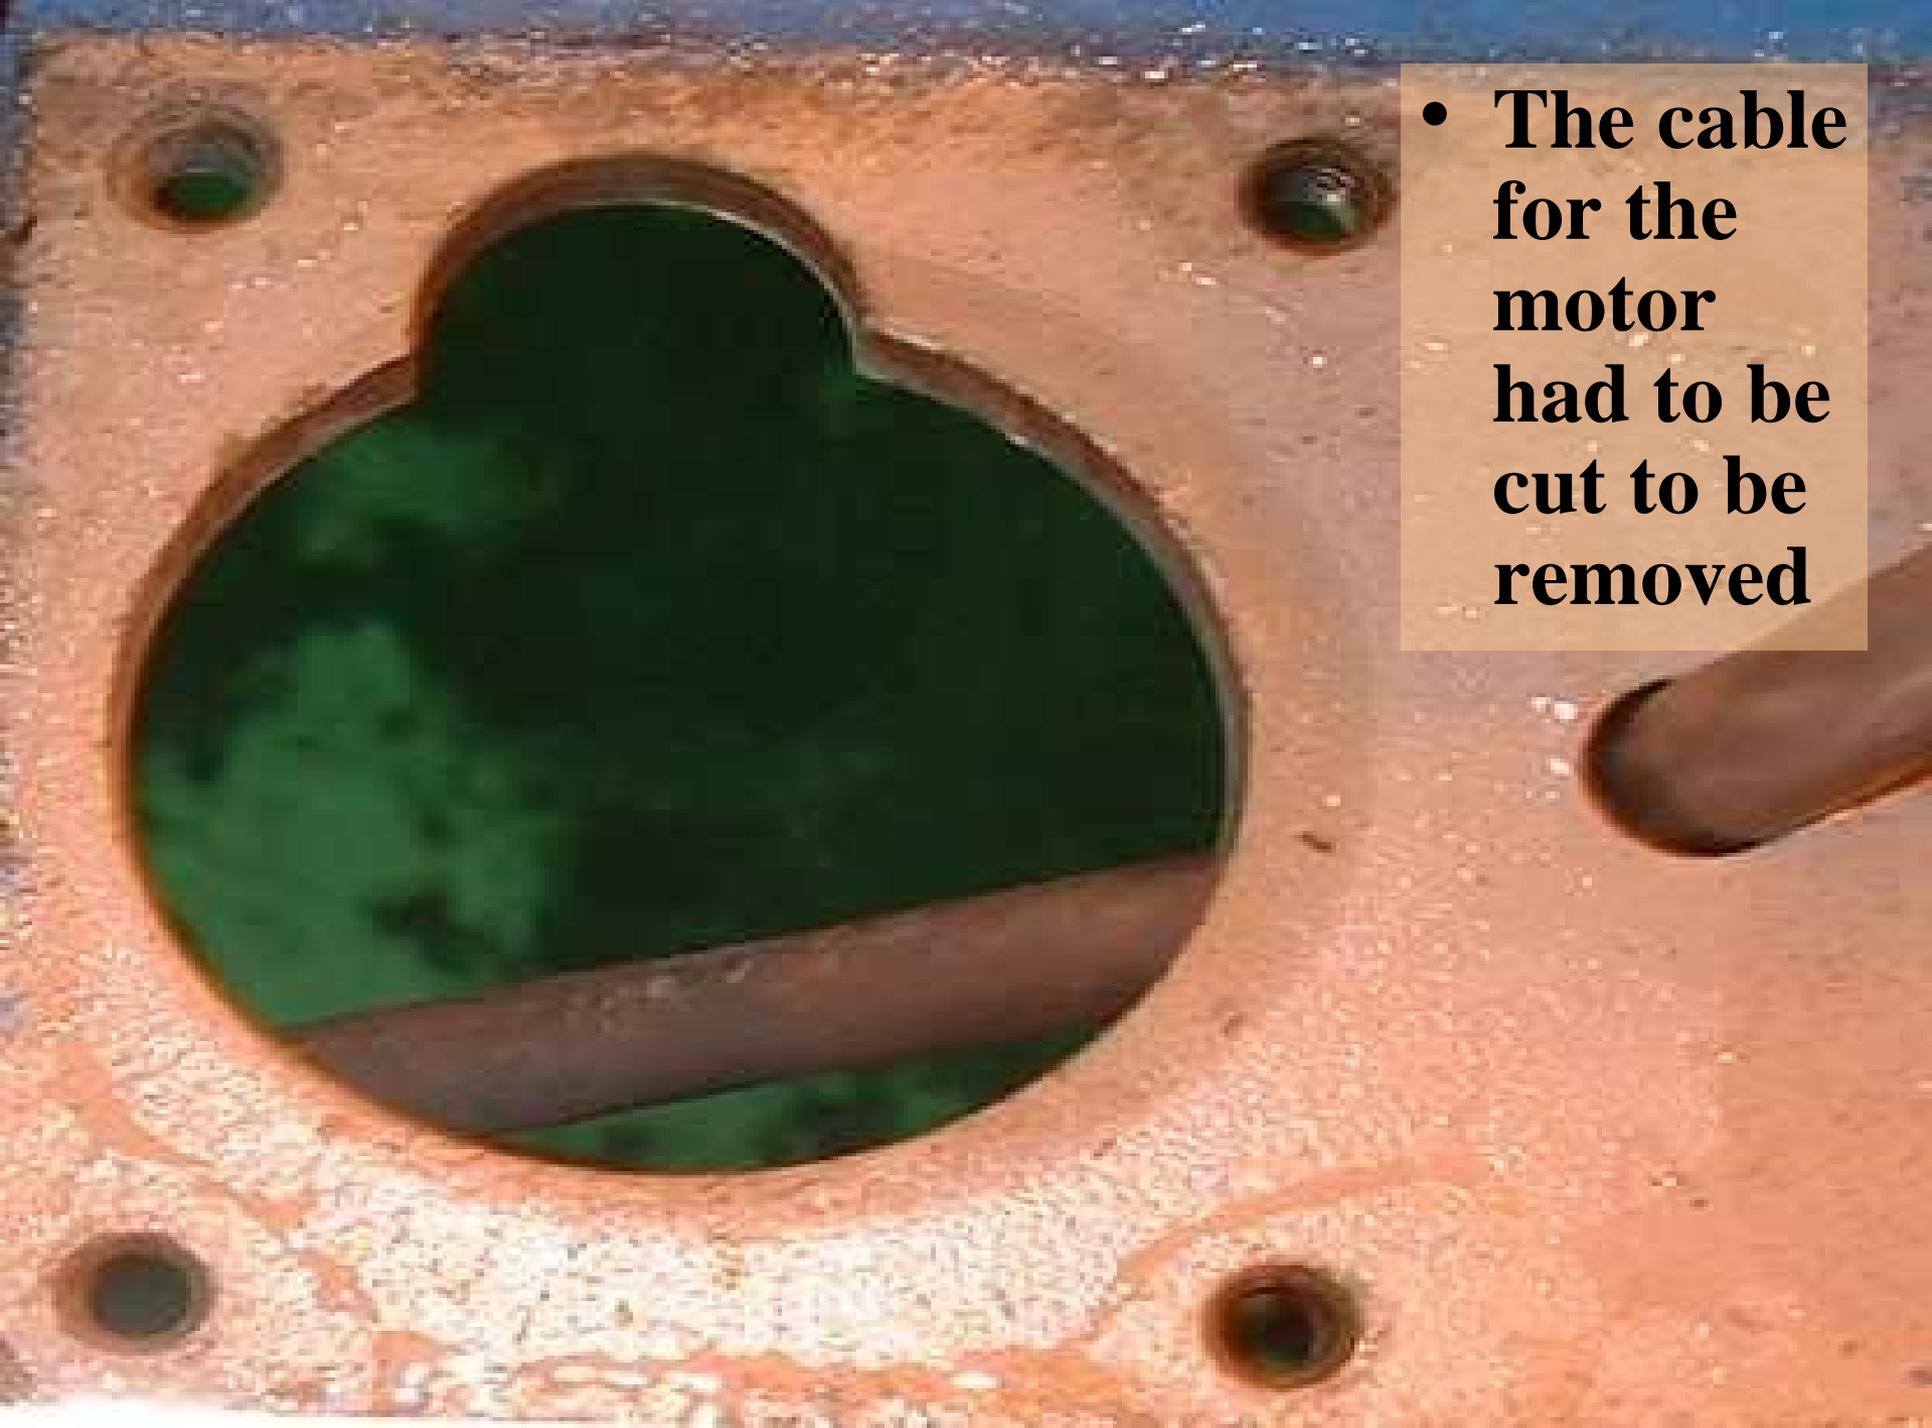
- **The cable for the motor had to be cut to be removed**
