Operations

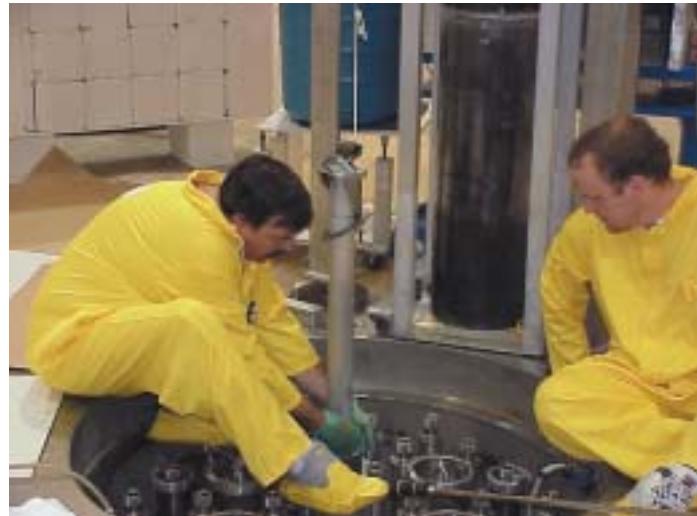
FIGURE 1. Bill Mueller and Greg Heller of the operations staff adjust the power-regulating rod.

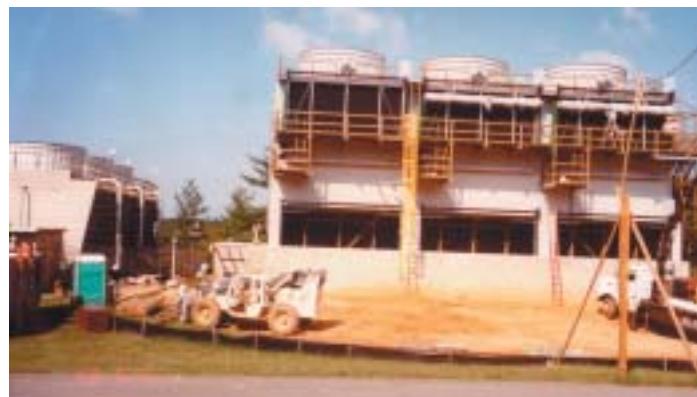
FIGURE 2. The new plume-abated cooling tower (right) nears completion. It will replace the lower capacity and less efficient system that had no abatement ability (left).

The NIST neutron source (NBSR) operated for 240 full power (20 MW) days during the past year, or 100 % of the scheduled time. Routinely, the NBSR is scheduled to operate a seven-week cycle, seven times a year. Each operating cycle includes 38 days on-line and 11 days shutdown for refueling, routine maintenance, and surveillance tests. (Figure 1 shows the operations staff adjusting the power-regulating rod.) This year, four days in March were required for maintenance on the Thermal Column Cooling System. The NBSR was shutdown on August 26, 2001, for a planned maintenance period of three months. During this time the cold source will be replaced, building transformers and switchgear will be replaced to provide additional electrical capacity, and the new cooling tower will undergo final hookup and testing. (Figure 2 shows the new cooling tower in the final stages of construction. For comparison the old cooling tower is seen on the left.)
